EVBIKE – how to fix the axle problem – 5/2015

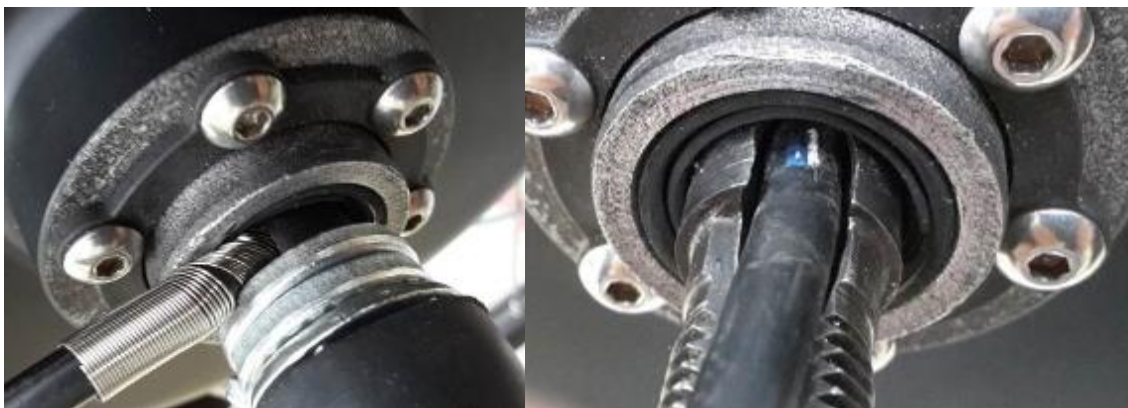
Dear customer, we are apologize for the problem with product. During season 2Q 2015 could have problem with rear HUB axle. Some products has loose the material near the cable going out of the axle. This proble can cause serious damage of motor (ERROR code 24 on LCD display).

Three pictures bellow showing the problem:

To avoid the problem – before you damage (cut the wires). It must put the spacer, which is substitute the missed material. The spacer is really simple and could be made during few minutes, from the original spacer, which is supplied with the motor.

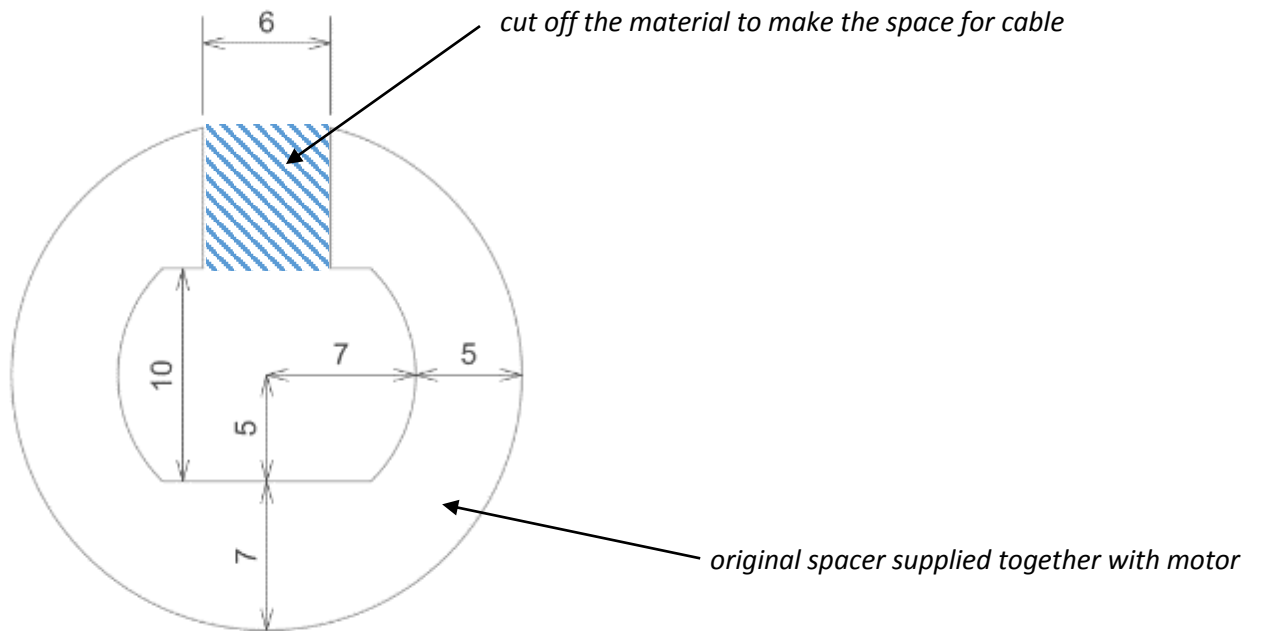
Make your own spacer with following dimensions:

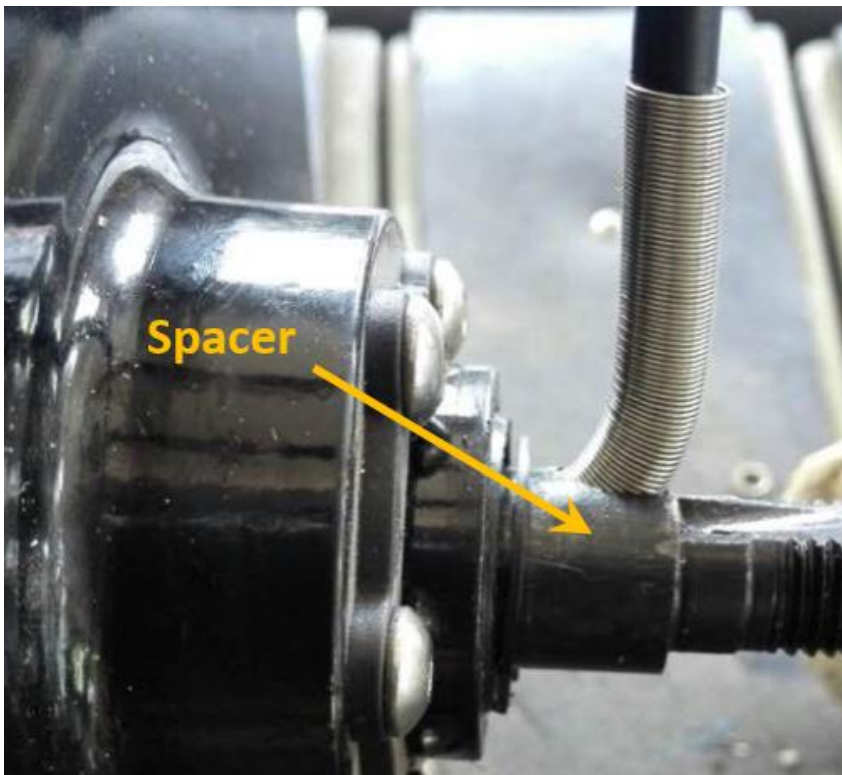
See another spacer which substitute missed material:
